BLACKBURN CREEK CDD

STORMWATER SYSTEM INSPECTION PHASE 3

Prepared for:
Blackburn Creek CDD

Prepared by:
Brletic Dvorak Inc.
436 4th Ave. S., Unit 4
St. Petersburg, FL 33701

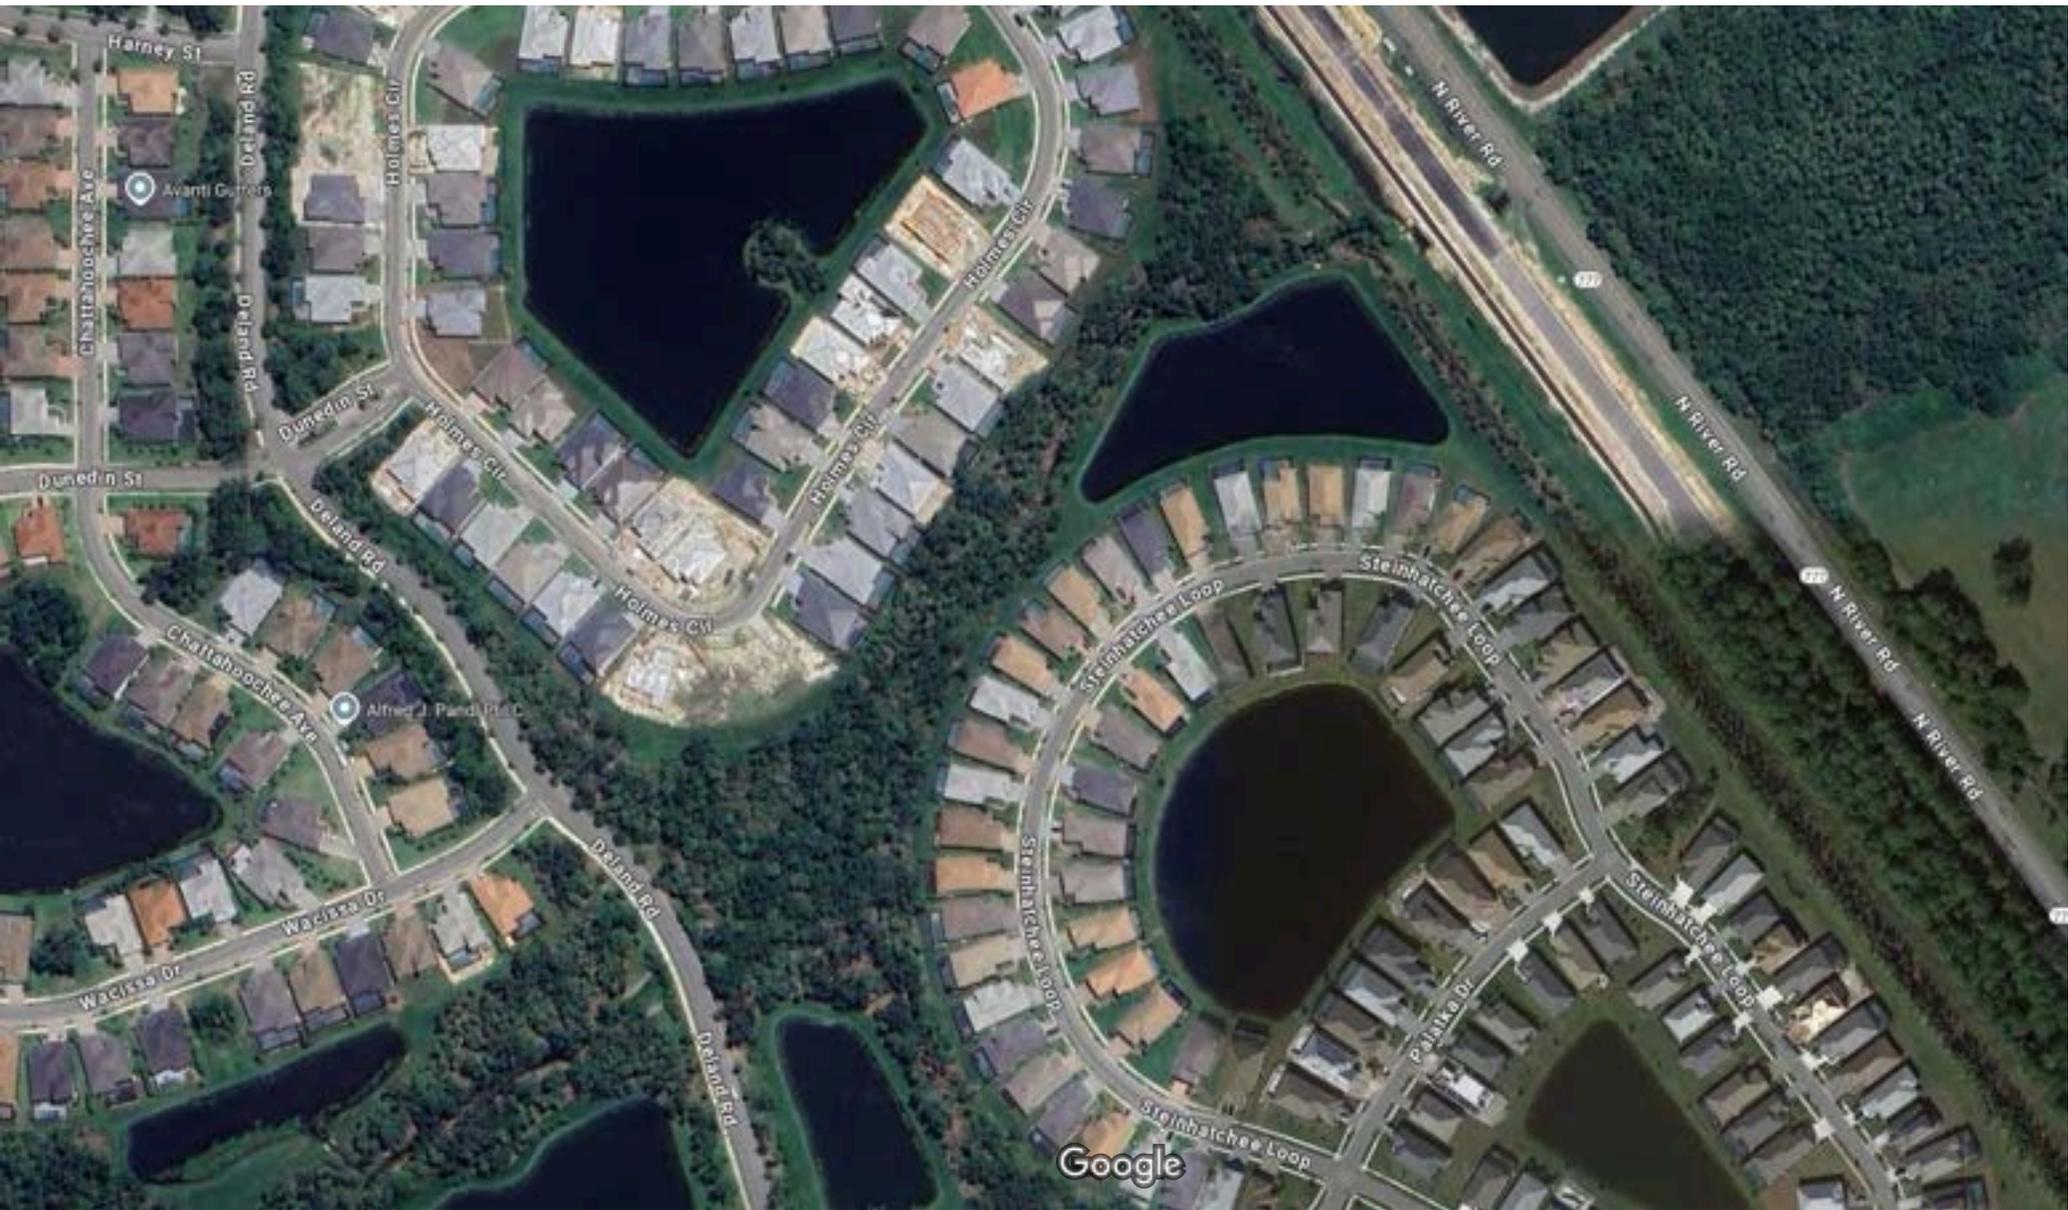
Marked Plan Set Documents for Maintenance Work

1. Recommend the removal of vegetation, debris and sediment from control structures, grated swale inlet(s), drainage swales and channels as identified in the following exhibits.

6. The weir structure on pond 12A had water flowing from the wetland tributary into the pond. Based on elevation readings in permitted plan set for permit 24192.011 sheet A-4 and the elevation reading for the opening of the weir found on sheet B-12 of the as built plan set for 24192.011 the water should be flowing out of the pond and not into the pond. This anomaly is resulting in elevated water levels in ponds 12, 12A, 13 and 13A and in the stormwater pipes and curb inlets.

- c. Incorporate appropriate erosion control measures such as silt fence and inlet protection at active construction sites.
4. Recommend addressing Pond 12A weir to restore outflow of water from pond 12A into the wetland tributary. In addition this structure will need the missing skimmer board replaced.

6. Removal of the unpermitted structure at pond 12A
